PHOTOGRAPHIC INTELLIGENCE REPORT

STATUS OF NORTH VIETNAMESE RAILROADS

REPORT NO. 37  
CIA/PIR 75113

DATE APRIL 1967

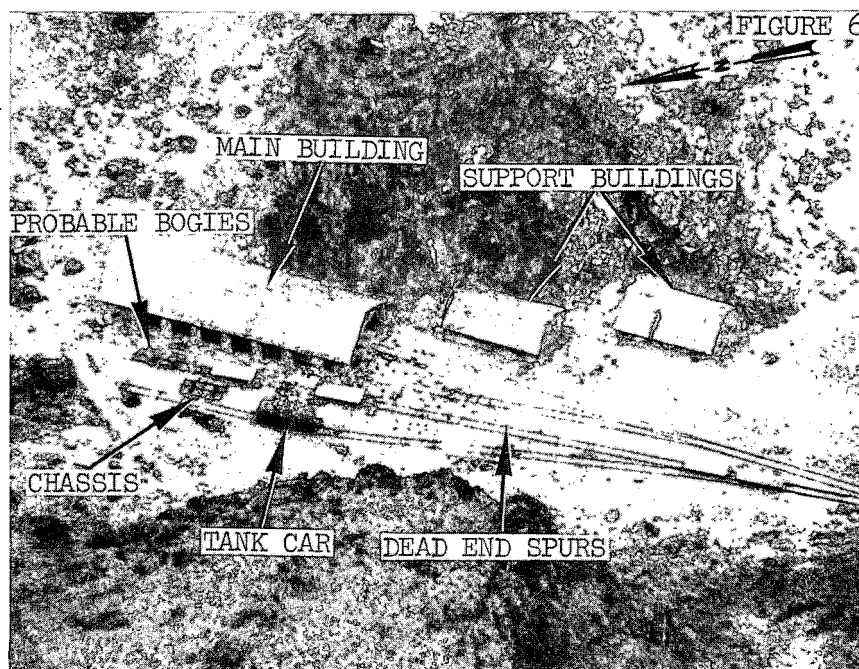
A newly identified probable repair/construction facility is located approximately 1.6 nm SW of the Thanh Hoa Railroad Station, Yard, and Siding  on a spur track. The facility consists of a 30' x 110' main building, two 20' x 45' support buildings, and 4 dead-end spurs (including 2 terminating in the large building). The facility is apparently designed for the repair and/or construction of small 2-axle rolling stock only. At least 22 small 2-axle flat cars (partially illustrated) and one 2-axle tank car were observed on the spur tracks in the vicinity of the facility, and the chassis of a small flat car was observed adjacent to the large structure. Two probable bogies were located on the track adjacent to this same building. No equipment could be seen within any of the buildings.

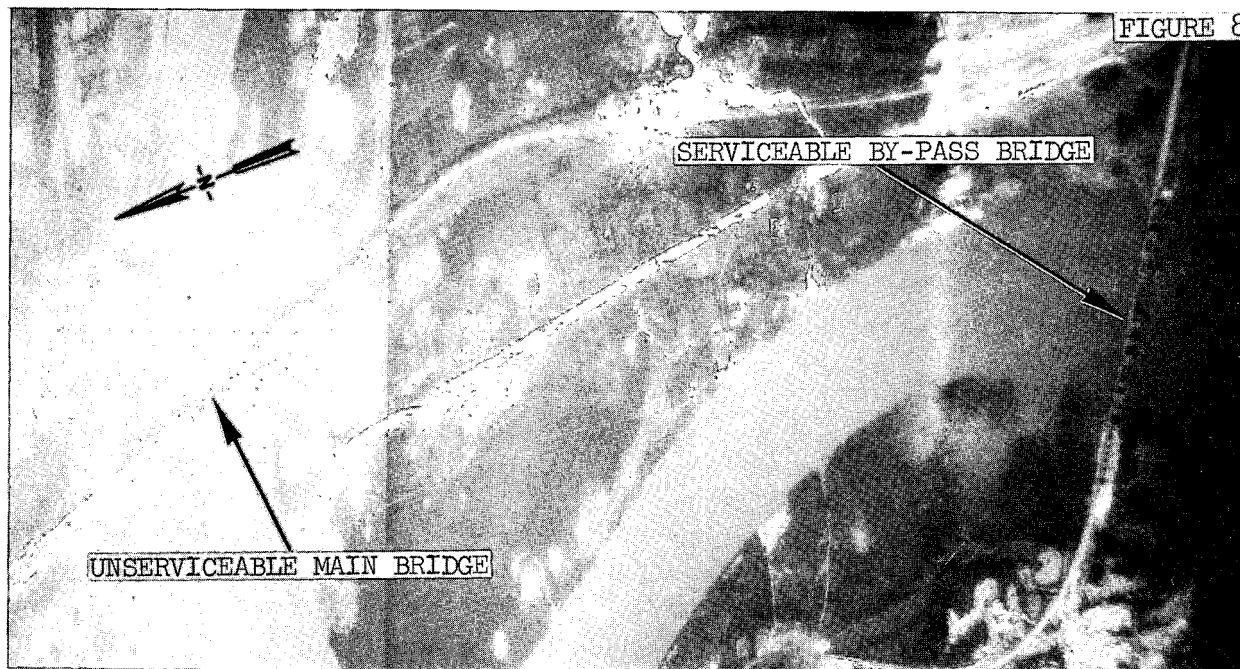
FIGURE 8

The multi-span deck-beam Tam Da Railroad By-Pass Bridge has been repaired and is serviceable. The main bridge is still unserviceable.
